Ironwork Conservation

Condition Surveys | Assessments & Advice | Specifications
Consultants in historic decorative architectural ironwork

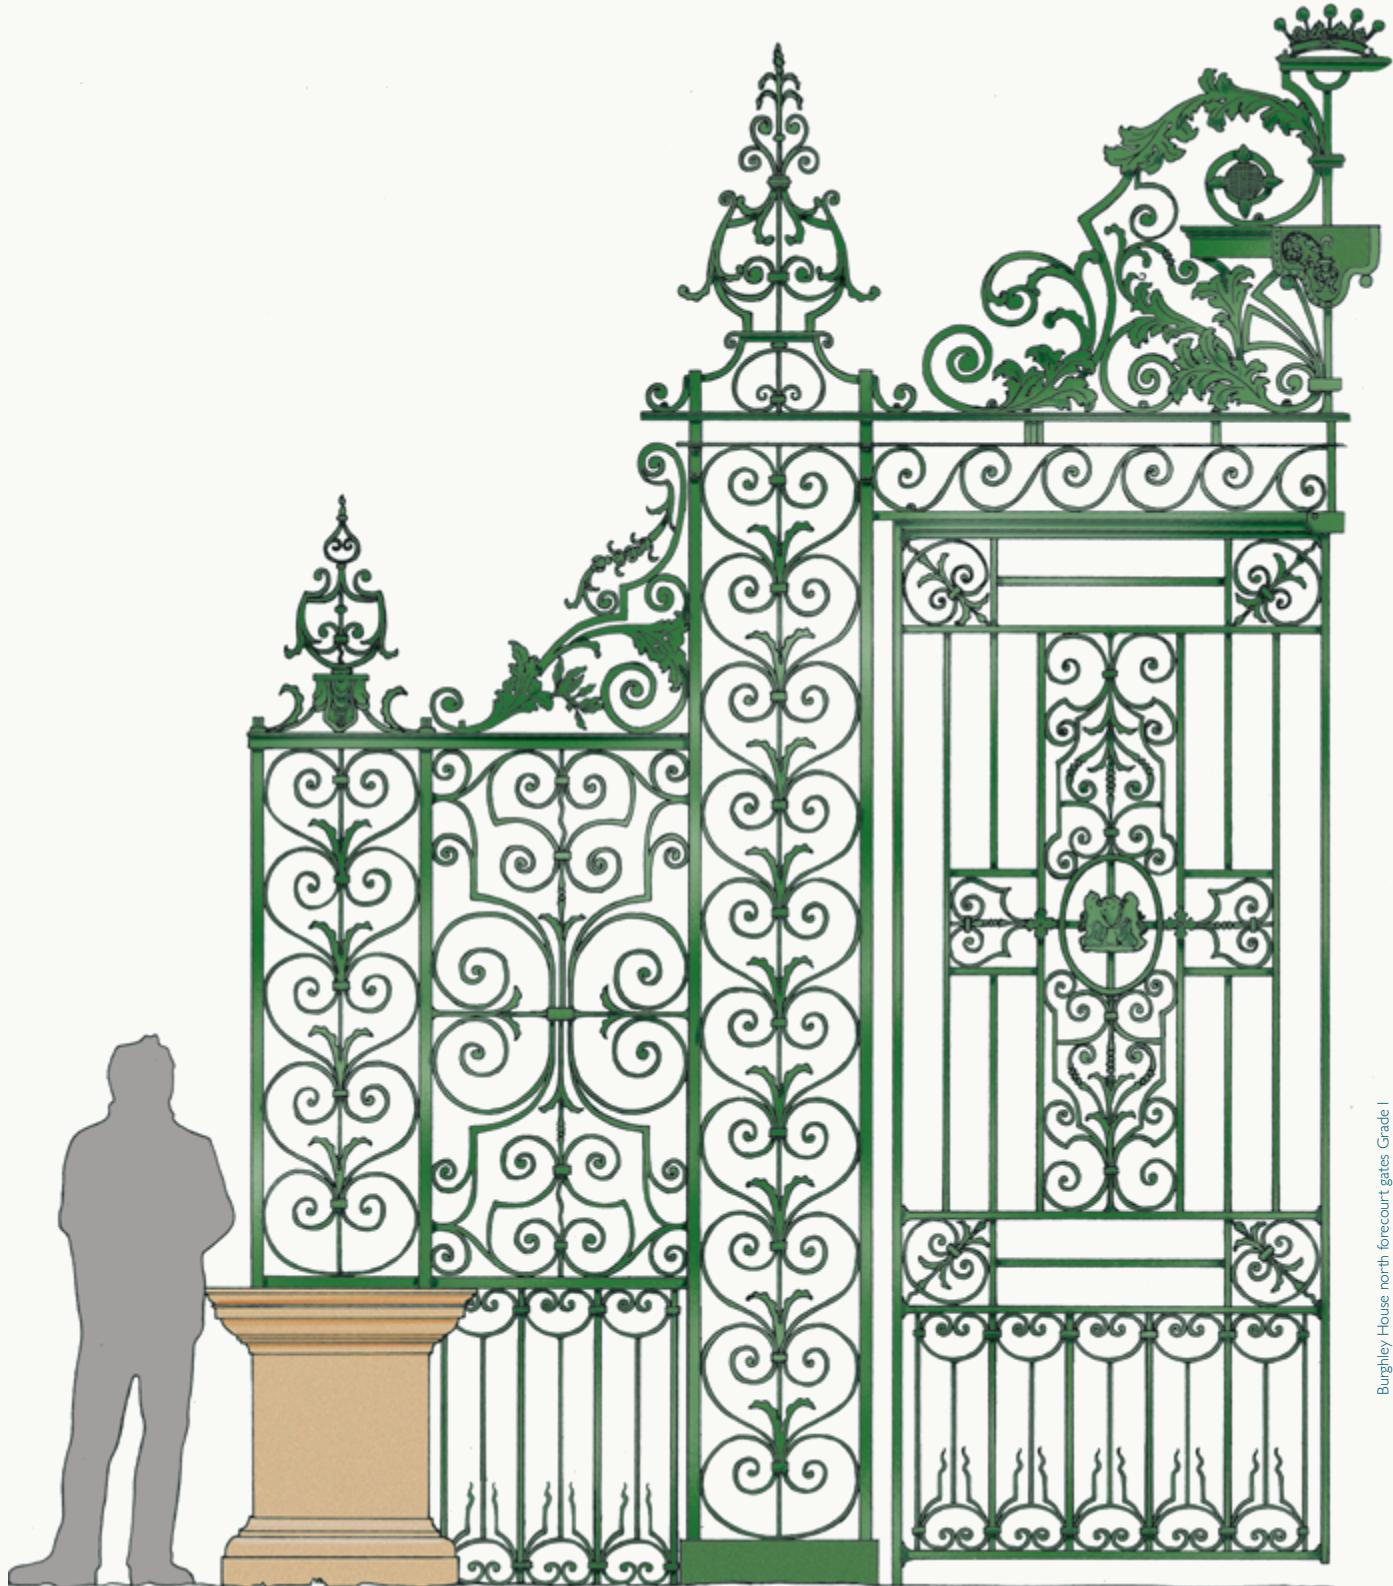
Burghley House north forecourt gates Grade I

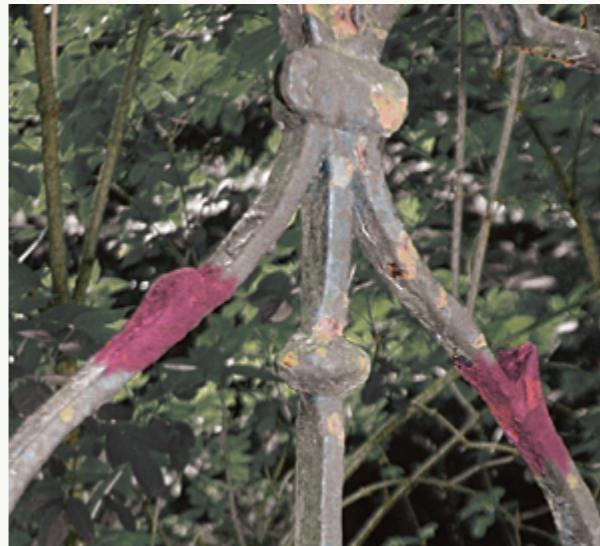
Stubs evidence missing components above fire welded branch joints.

In this case study, analysis of the physical evidence helped identify the date this ironwork was created as early 18th Century. This assessment included details such as:

- **Design style** – stubs can evidence the remains of joints where additional branch forge welded scroll and leaf work once was. These can be used to demonstrate the original design intent and thereby assist period fashion identification.
- **Corrosion** – frequently corrosion results in severely damaged or missing components, but the type and location of corrosion can help identify construction techniques and original design style.
- **Construction detailing** – is a good indicator of the technology available at the time of manufacture, which can be reviewed against knowledge of technological developments.
- **Materials** – can also relate to technological developments, in this case the use of charcoal wrought iron which was only produced up to the end of the 18th C, prior to the invention of puddled wrought iron.

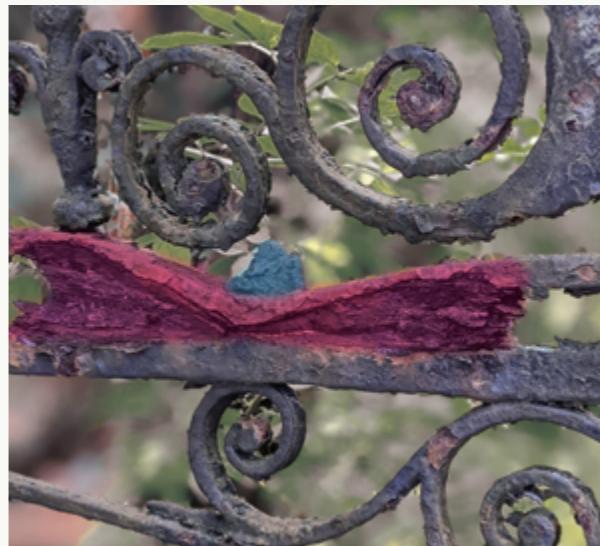
U shaped collar joined with a flat bar riveted in place is characteristic 18th C cold fitting technique.

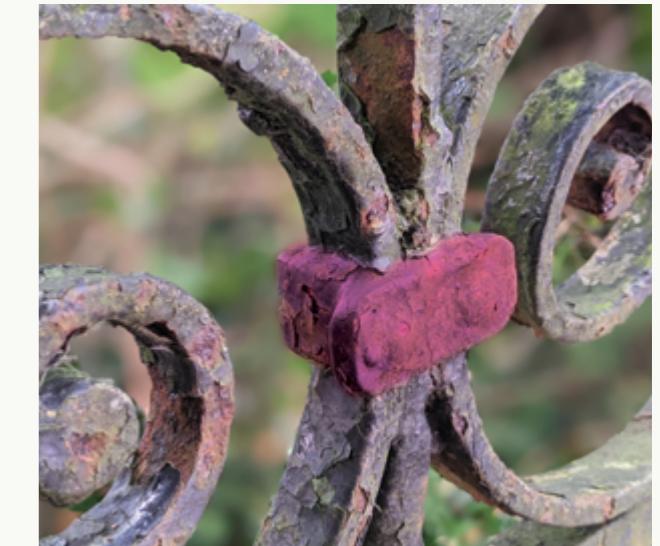
Typical 18th C wedge joint (blue) holding overthrow to stretcher frame, distorted by rust heave as a result of crevice corrosion.

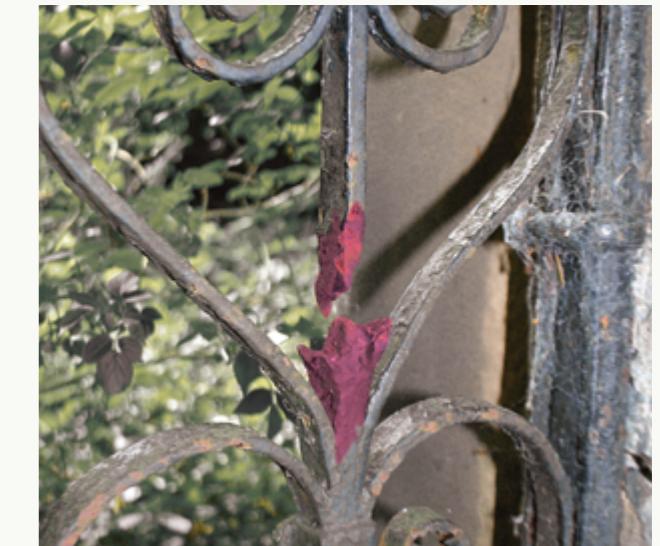
Evidence of two uprising water leaves branching from central stem with corrosion wastage resulting from the water trap they created.

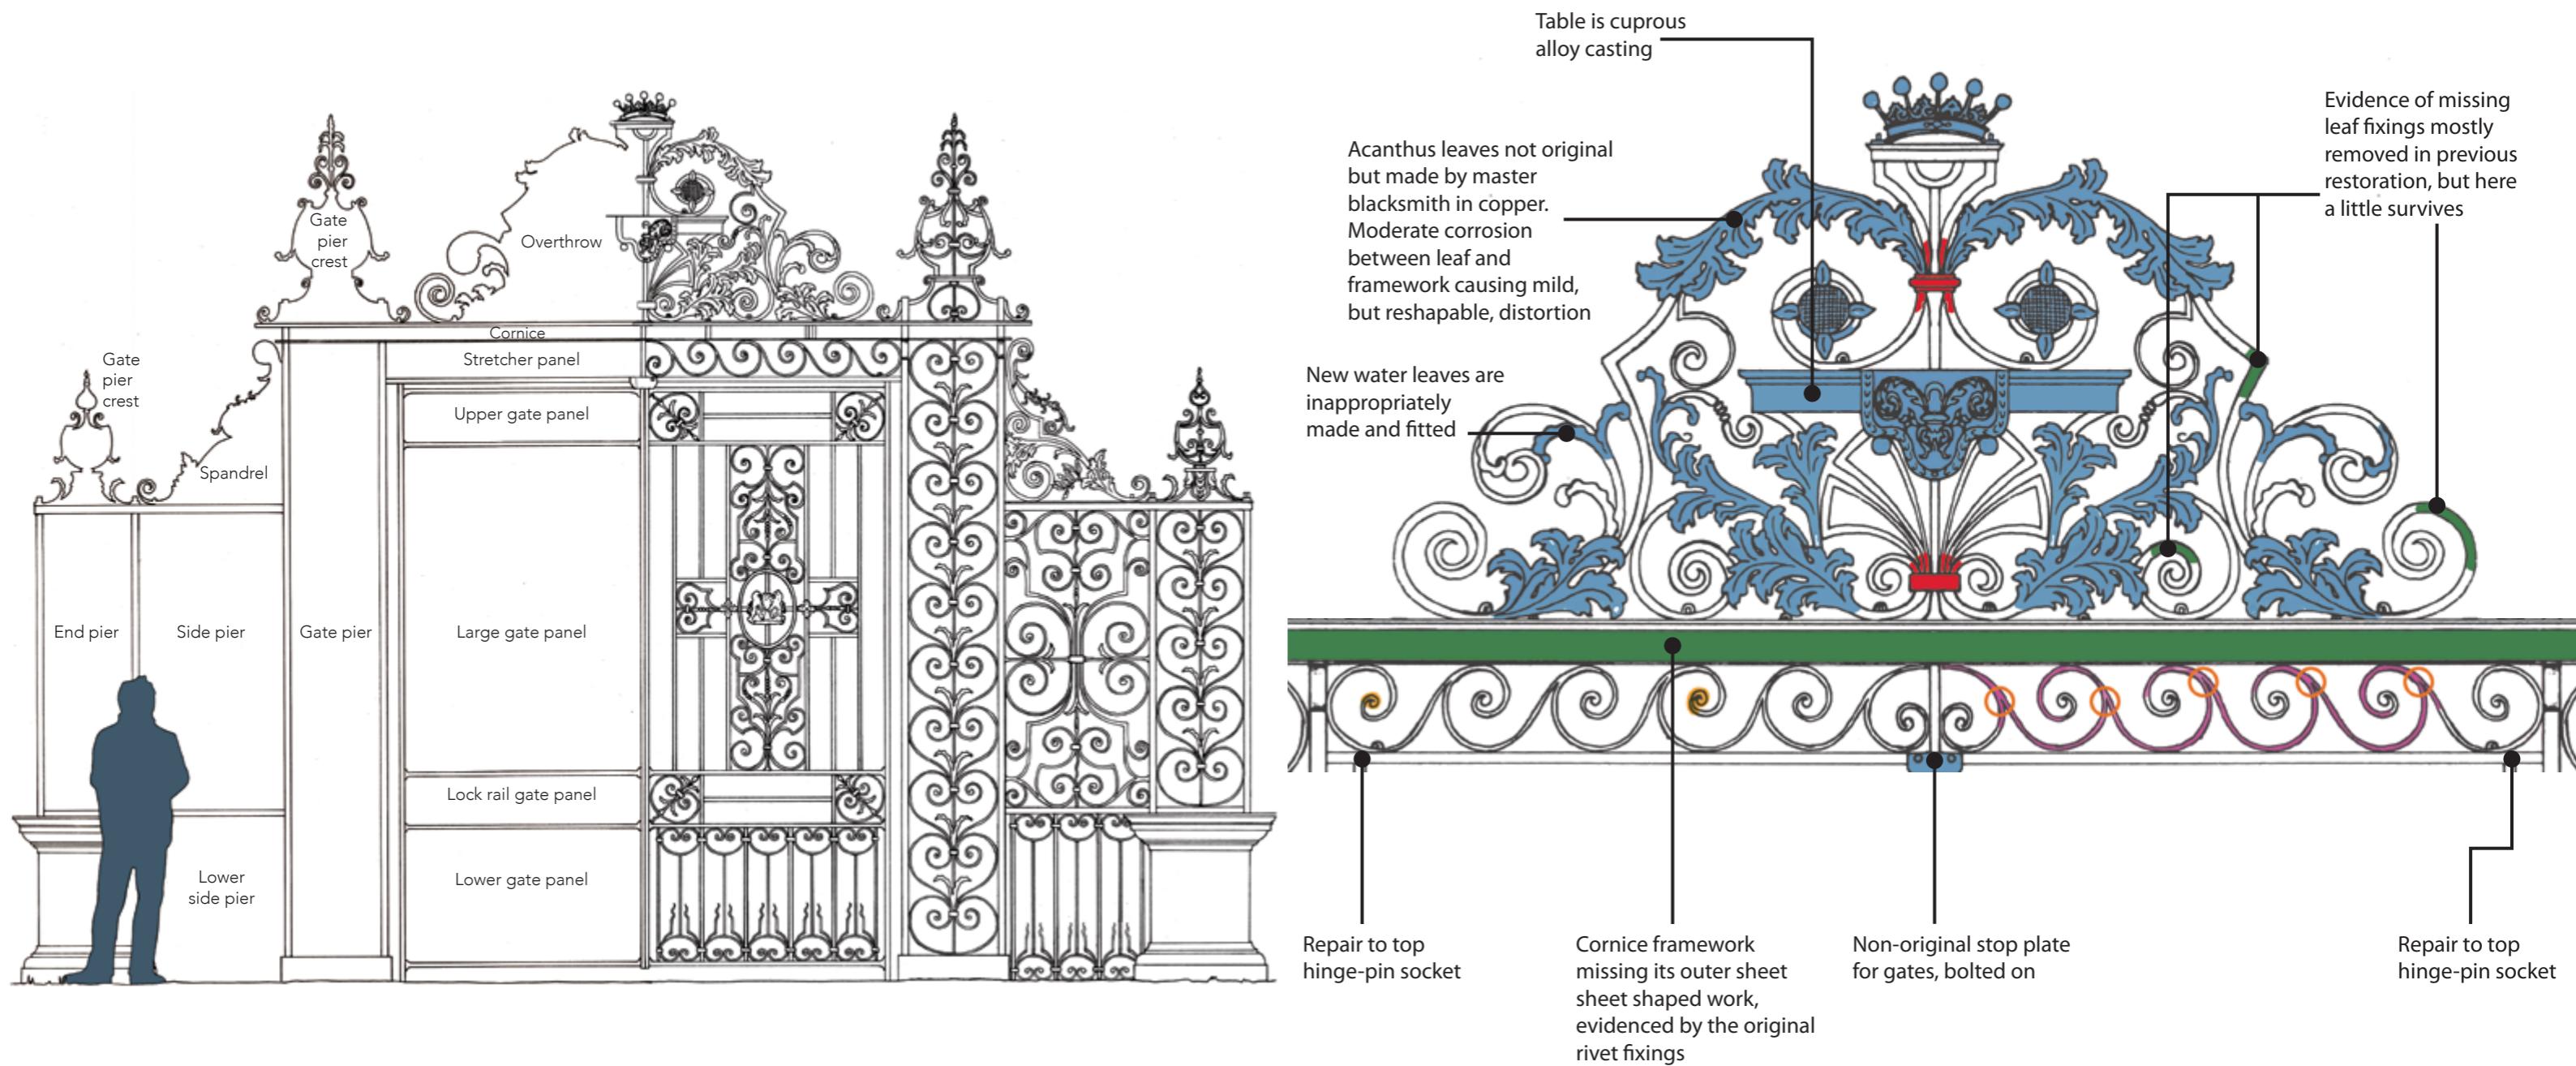
North forecourt gates (Grade I) at Burghley House, Stamford

Illustrations are an important part of our work as they enable efficient transfer of information to all involved in a project, no matter their knowledge and experience. In this project our general arrangement drawings not only provided a clear record of the design at the time of surveying, but a tool for use through all stages of current and future work. Within this project, for example, it was first used to create a pictorial glossary of the terminology and labelling system then later used for condition mapping.

- Orange: Moderate corrosion
- Red: Severe corrosion
- Purple: Damaged
- Blue: Alterations and additions
- Green: Missing elements
- Orange circle: Electric welding

This is a technique that enables the graphic documentation of survey notes in the context of the overall project. Visualising the relationship between different pieces of evidence recorded, condition maps assist the process of assessment. This example, showing the overthrow and stretcher panel, supplemented the broader and more general information within the condition survey report.

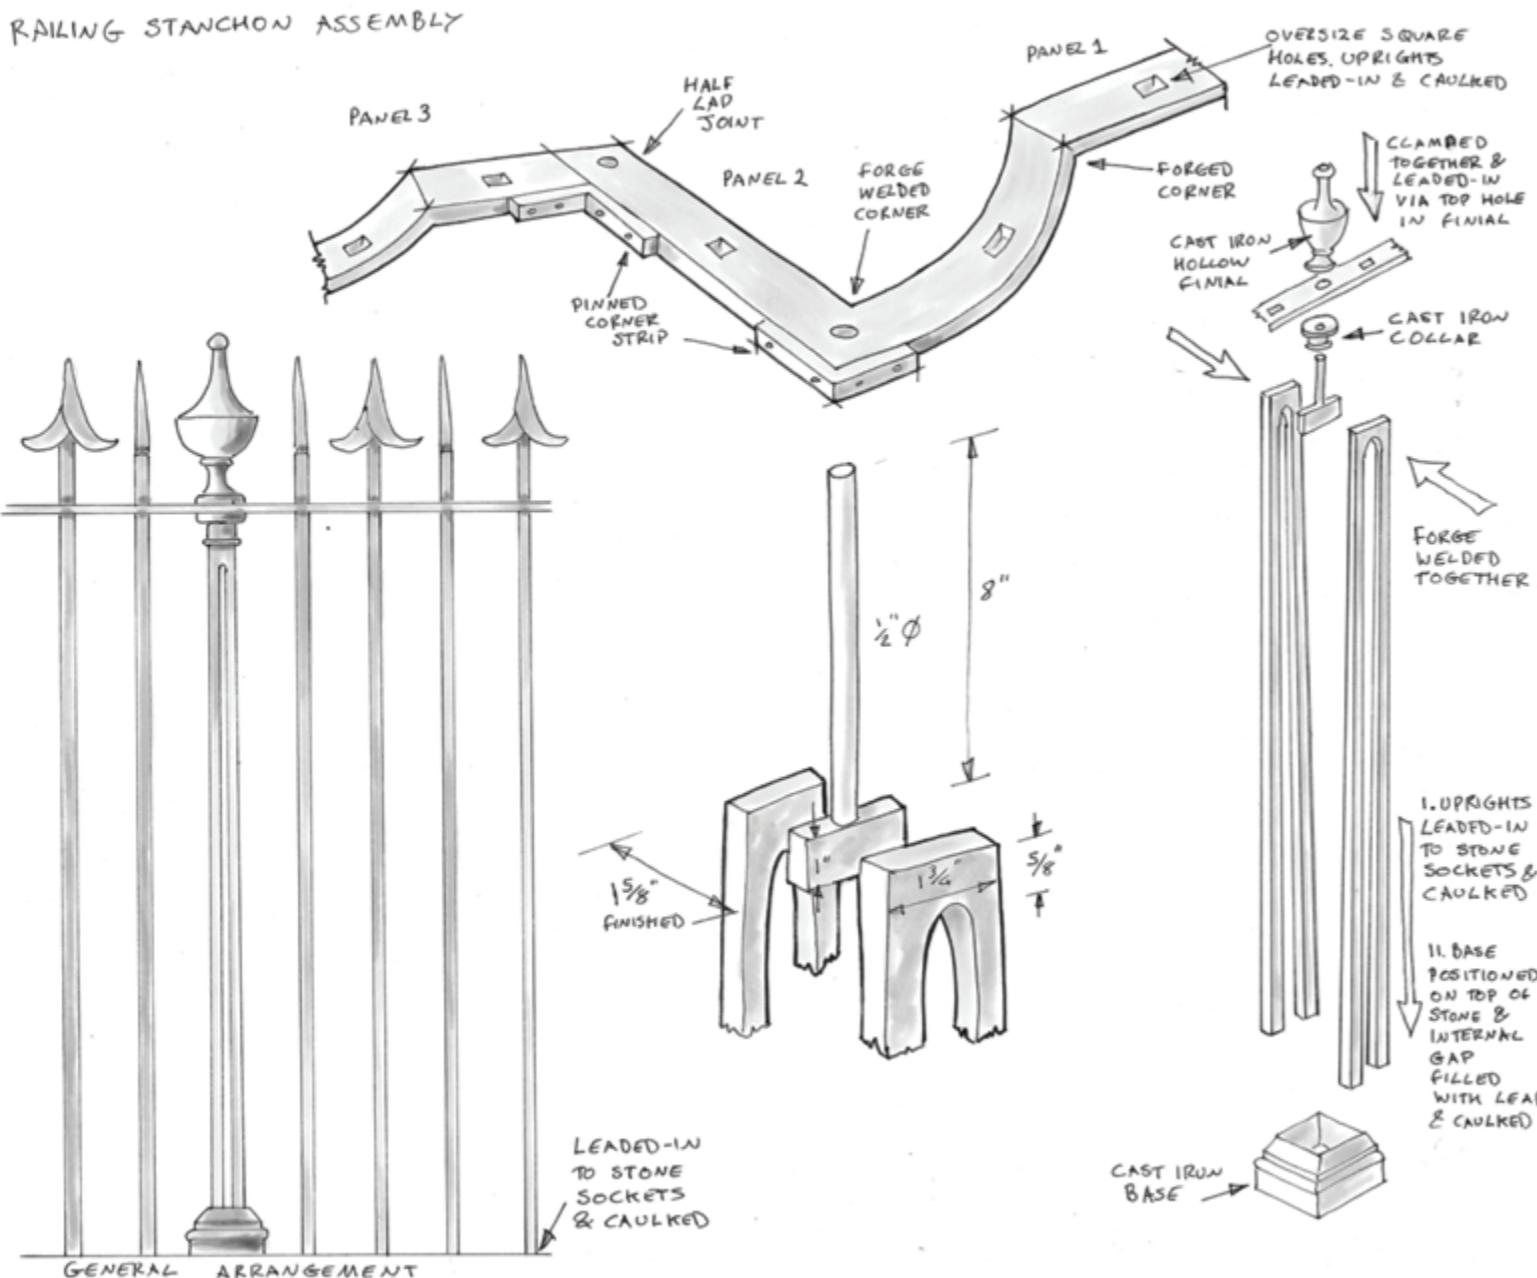
Queen Anne Summer House Railings (Grade II) Shuttleworth, Bedfordshire

Old ironwork can look deceptively simple by today's standards as, for example, these modest railings erected in the 1710's. While core blacksmithing techniques using forge, hammer and anvil are still the same today, it's important to remember that modern tools and technologies have provided alternative methods that have affected advanced skillsets which were once commonplace. As a result, understanding ancient construction methods requires a completely different mindset to modern work. Our exploded assembly drawings provide insight for appropriate budgeting and approach to dismantling and restoration works.

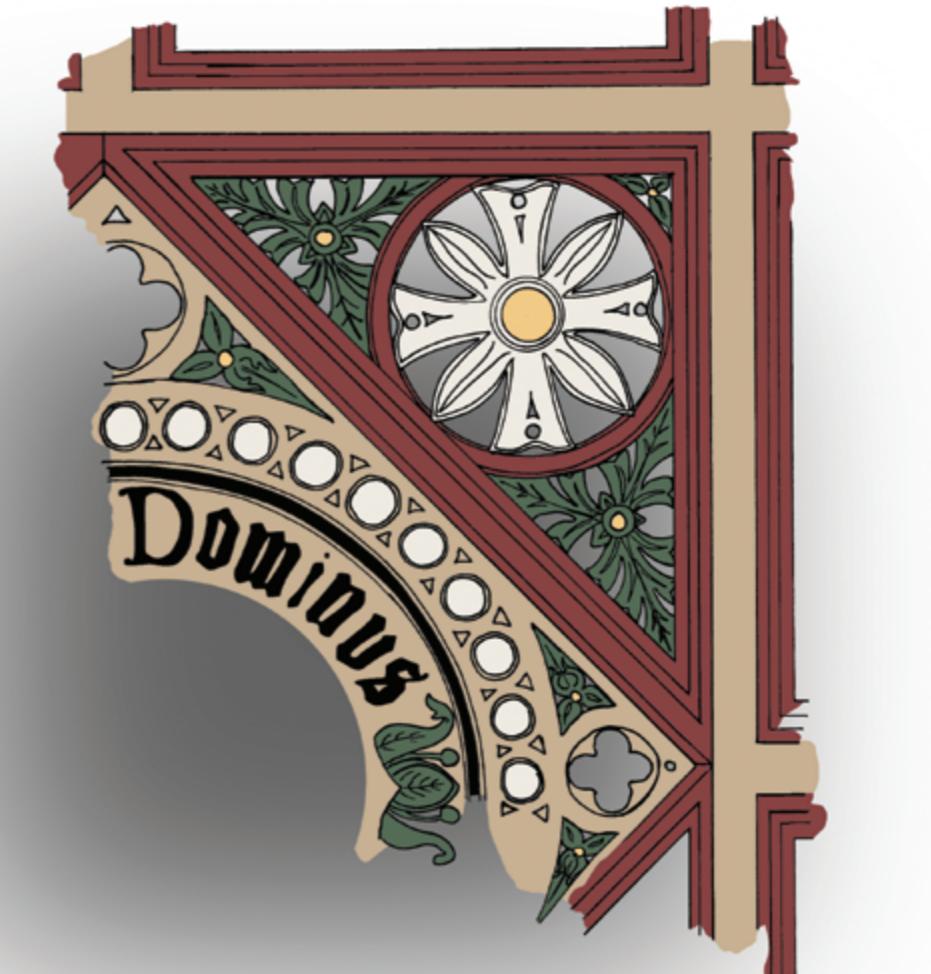
Piece Hall Gates (Grade I) at Piece Hall, Halifax

Item	Text; Border around crest	Panel Mouldings	Folage & Stems	Flowers & Studs	Frame	Flower Centres
Colour name	Black	Crimson	Chrome Green	Wiltshire White	Dark Stone	Sulphur Colour

Made in 1871 by George Smith & Co these gates comprise highly detailed and ornate cast iron panels within a puddled wrought iron frame. Being made before the twentieth century fashion for black, their original colour scheme would have been polychrome. Unfortunately, paint analysis confirmed that a previous restoration had thoroughly stripped all the original paint. The new colour scheme was therefore compiled using the client's crest as initial inspiration, with its colours referenced to known historic ironwork colour schemes from the same period as the gates' construction.
